Irrigation Development Support Project (IDSP) Ministry of Agriculture Government of the Republic of Zambia

Environmental and Social Management Plan

Remedial Works on Makaba Dam

11 January 2022

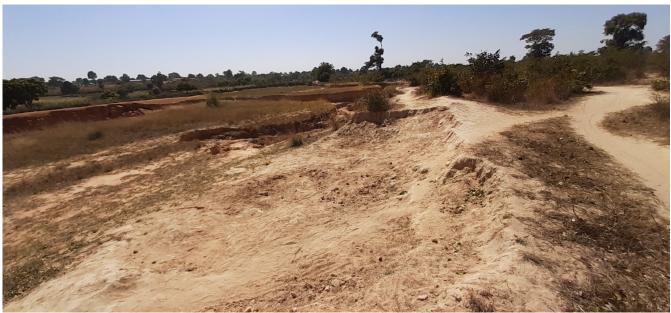
The other major sources of siltation and soil movements are the livestock watering points all around the basin and downstream. There were no visible top soil stockpiles on the site. These were possibly buried during excavations. The proposed works area is within the disturbed spillway and embankment zones.

Figure 2: Open slopes and gullies along spillway and towards embankment

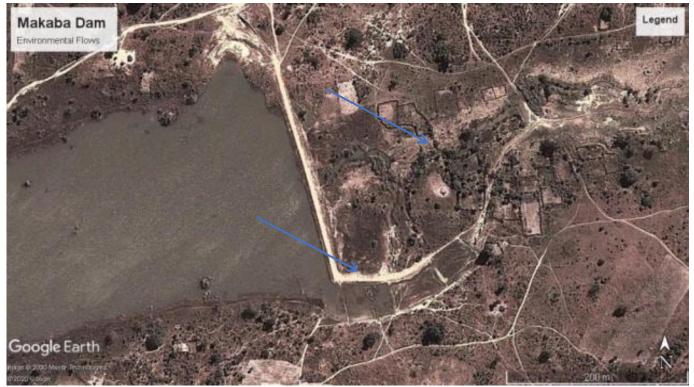
The dam has flow releases over the spillway. It also has unintended spillway seepage leading to increased and continuous downstream flows. According to the community, the Makaba Dam experiences reduced water levels in the reservoir during the hot season, but it has never dried up. This is related to the significant flows and catchment flows into the dam – mostly during the rainy season. Evident flows are shown below:

Figure 5: Downstream flows

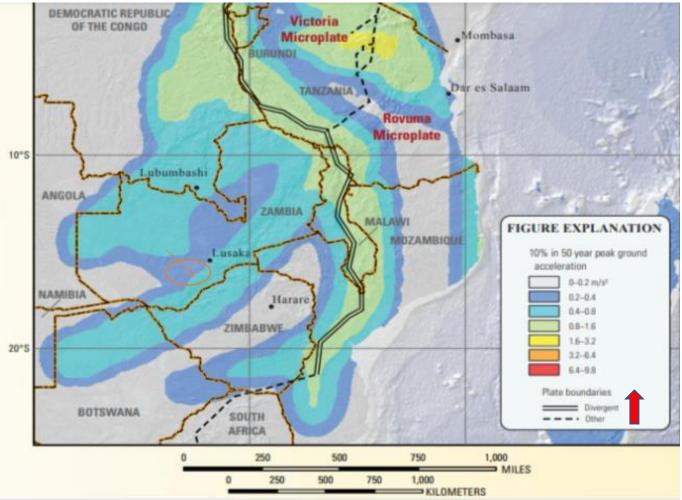
According to the US Geological Survey, the seismic hazard level is very low in the area of Makaba Dam. It is within the range of 0.4-0.8 m/s² (with 10% excess probability in 50-year PGA) (Figure 7).¹¹ Unlike large dams, small dams do not induce seismicity.¹² Furthermore, historical data on the performance of previously studied dams have shown

Figure 7: Seismic hazard, US Geological Survey 2013

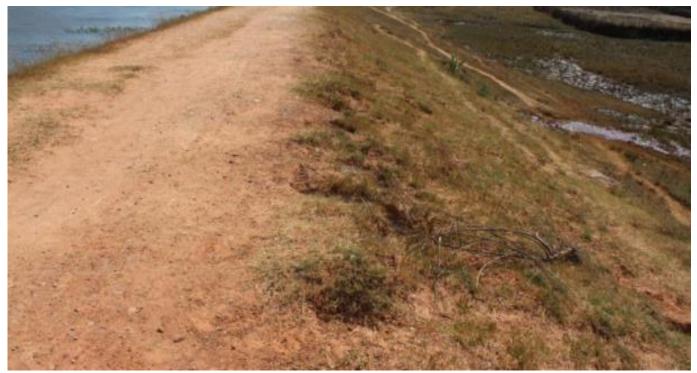
The embankment is not in good condition. While it has a reasonably uniform slope throughout, the left-hand end of the embankment is steeper than the central - main body – section. It then appears to steepen up again slightly as it nears the bend at the right hand end of the embankment, where it turns into the spillway training wall along the discharge channel.

General condition of embankment crest

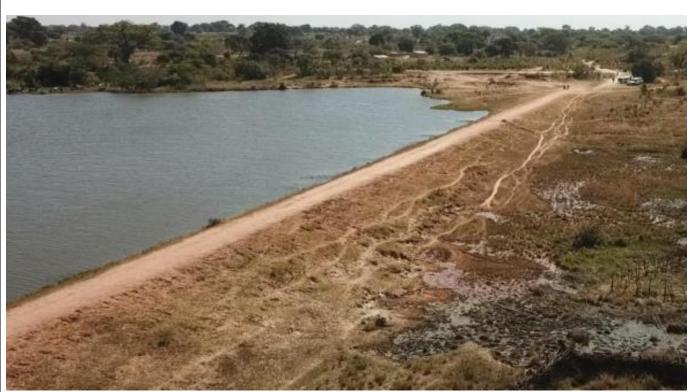
Seepage at and downstream of toe

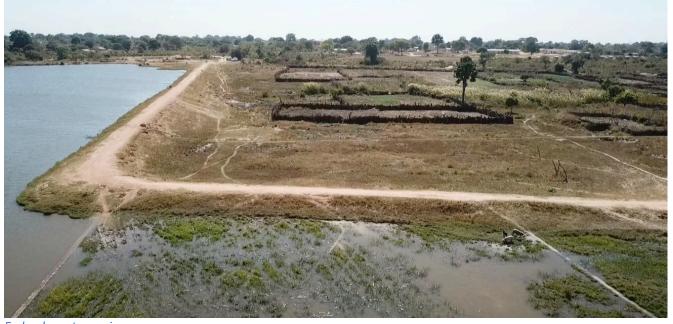
<u>Main Embankment – Crest, Upstream and Downstream Faces:</u> The overall condition of the main embankment - and to a large extent the whole structure- is relatively poor and in need of remedial works. Seepage at the downstream toe and unrestricted livestock access -as evidenced by the footpaths along the length of the downstream embankment face - is exacerbating the problem.

Embankment overview

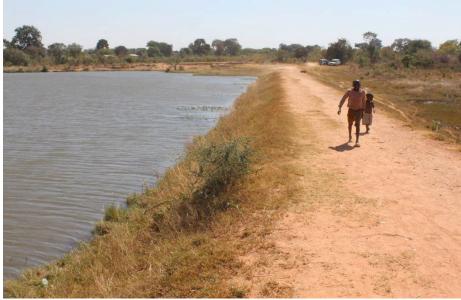
<u>Crest:</u> The crest is generally in an average condition and with a fairly uniform width of 3.5m+ (with a few sections that may make it out to 4m). Both upstream and downstream crest edges show varying degrees of breakaway and the beginning of gullying. It appears that the embankment crest has had more material placed on it at some stage as the last portion of the upstream and downstream faces seems to steepen up considerably to the crest.

Typical condition of main embankment crest

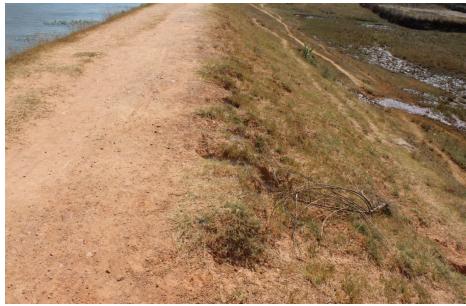
Downstream crest showing breakaway and gully formation

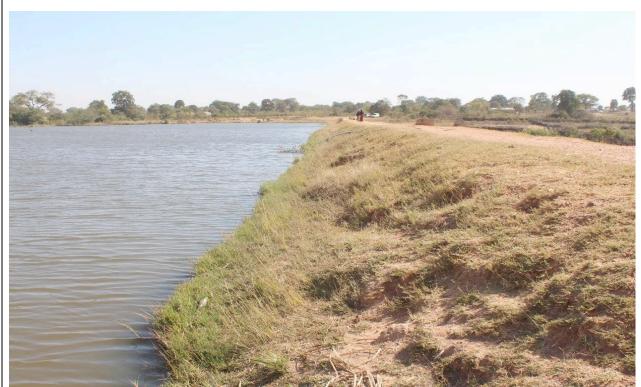
The front face grassing is possibly inadequate for the fetch and the fact the dam seems to be full for most of the year. There is also some "beaching" below the current waterline, but it is not extensive. There are a few small trees growing on the front face .

Front face condition

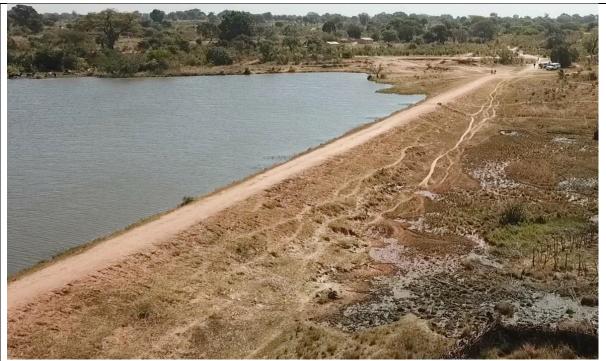
<u>Downstream Face</u>: The downstream face is not in good condition although it does have a reasonably uniform slope throughout. The left-hand end of the embankment is steeper than the central - main body - section and then it appears to steepen up again slightly as it nears the bend at the right hand end of the embankment where it turns into the spillway training wall along the discharge channel. The main body of embankment has a relatively flat slope of between 2:25 and 2.5:1. The top section of the face steepens up close to the intersection with the crest – possibly due to more material being added to the crest at some stage. There is no seepage exiting the embankment above the toe line indicating the phreatic surface is totally within the embankment, which is positive in terms of embankment stability. There are many livestock (mainly cattle) footpaths criss-crossing the downstream face, all adding to the erosion that has taken place. In particular, the trampling in the seepage areas at the downstream toe has caused sections of the embankment to cut back.

Downstream face of embankment - gullying and livestock footpaths

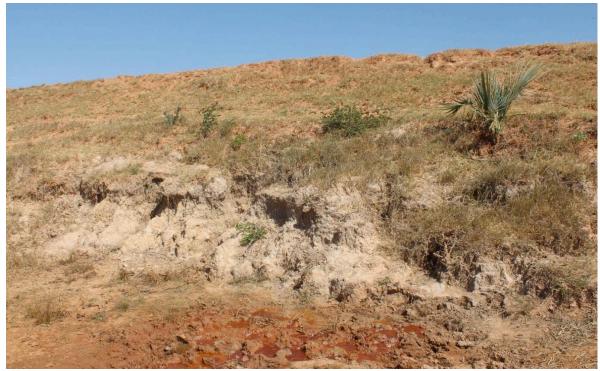
Downstream face of embankment - cut back of toe, trees and gullying

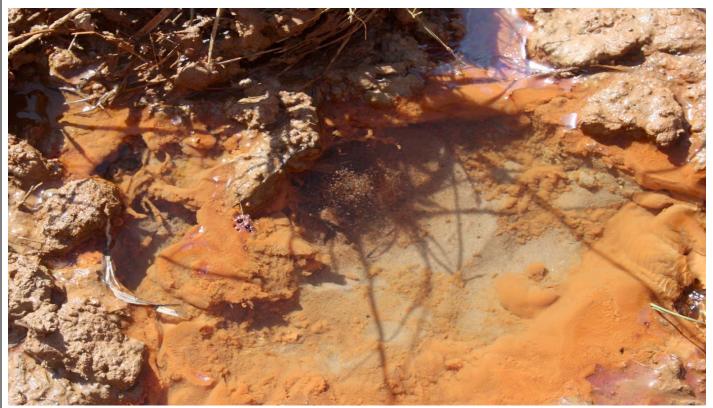
which means that the uplift pressures in these regions are high and could have serious stability ramifications for the embankment.

"Boil" evident in seepage near rock toe

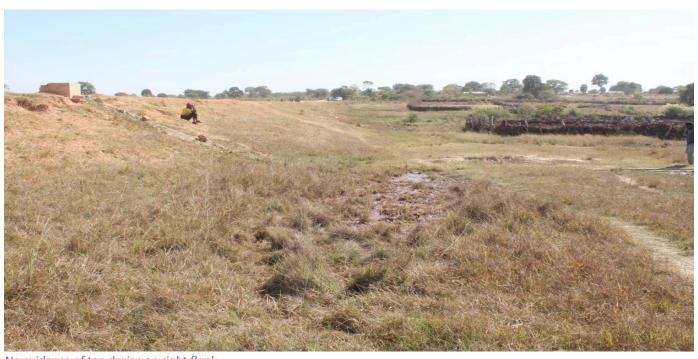
No evidence of toe drains on right flank

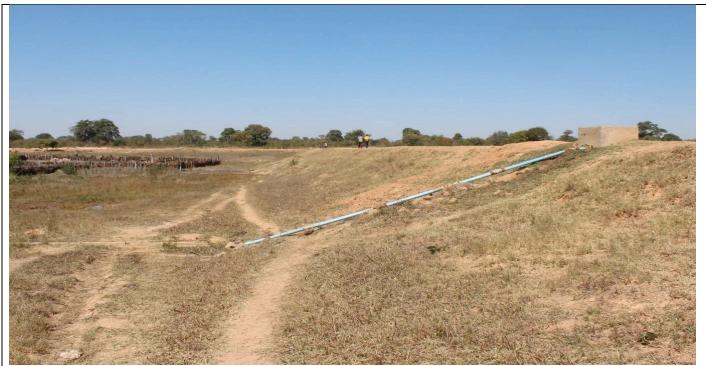
No evidence of toe drain on left flank

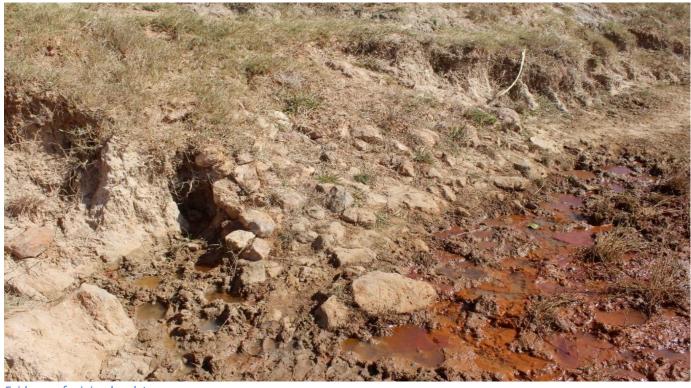
<u>Downstream Rock Toe</u>: There is some evidence that some kind of rock toe was placed during construction. However, it appears to have been minimal in size and effectively non-existent. There are no original construction drawings.

Evidence of minimal rock toe

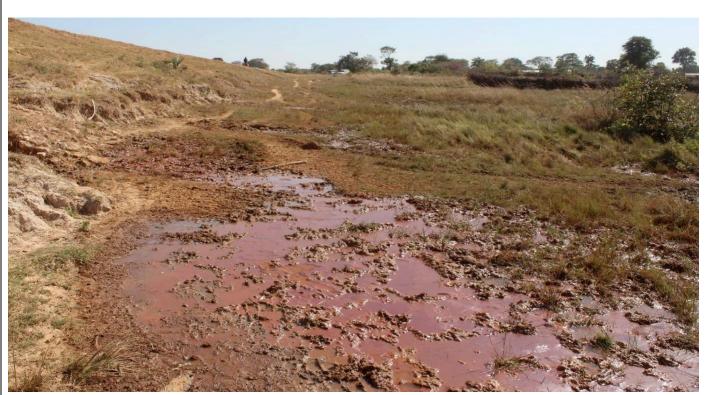
Seepage wet spot near rock toe location

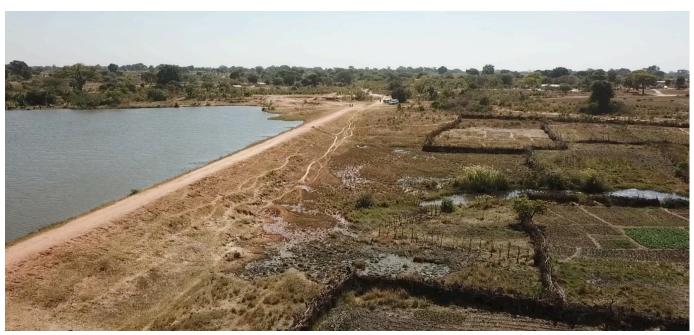
<u>Downstream Seepage</u>: There is seepage evident at several places along the length of the embankment toe as well as in the low spots on either side of the original river line downstream of the toe. There are a few "boils" present and observable flow from the spots just to the left of the rock toe. While the standing water in the stream is only a short distance from the toe, the whole area between the toe and this point is very flat and wet and spongy.

Seepage at toe and downstream to the river line

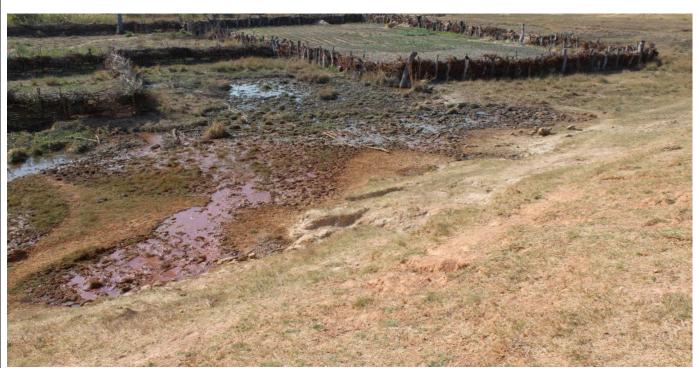
Seepage at rock toe and right flank of river

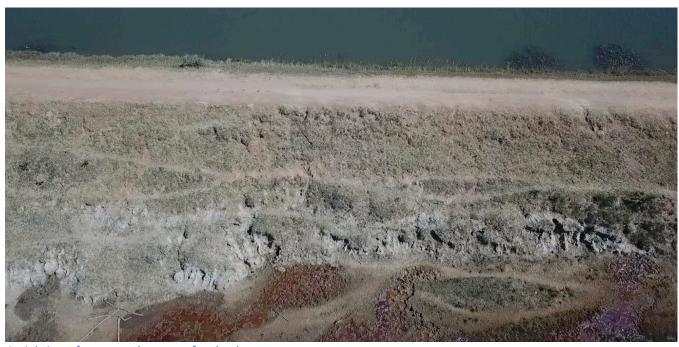
<u>Seepage at Toe vs. Seepage Downstream of Toe</u>: Seepage appearing at the toe is considered to be primarily water passing through the embankment's internal drainage system and daylighting at these points - though on the left bank there may also be an element of water passing through or under the key trench. This can be seen at the large mushy area and the through the fact that the embankment is cut back by being trampled by cattle.

Aerial view of seepage along toe of embankment

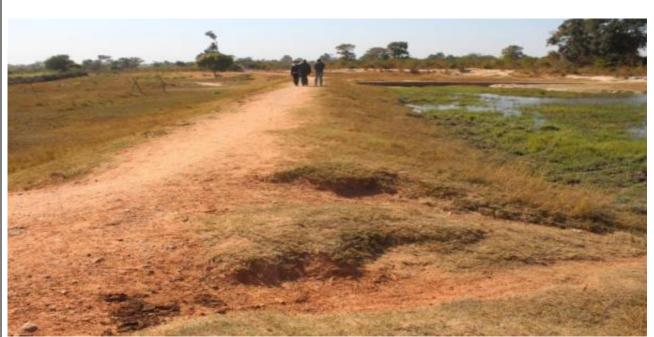
<u>Embankment at Service Spillway Concrete Sill</u>: The 90-degree bend in the embankment leading into the spillway discharge channel training wall is part of the river crossing point for the local population on the right bank of the dam. The heavy foot and bicycle traffic at this point has badly eroded the front face of the embankment. Although the concrete spillway sill is approximately 40m wide, the distance to the shore on the other bank is about 50m at HFL due to the lack of any spillway abutment wall.

Embankment end at spillway sill showing erosion damage

This is not an ideal situation with the potential for serious wash damage during flooding.

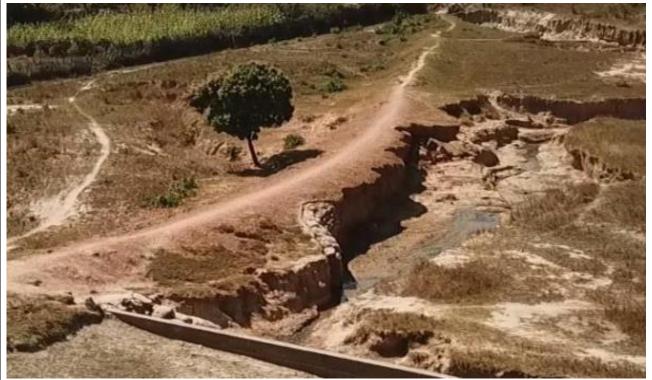
Spillway erosion

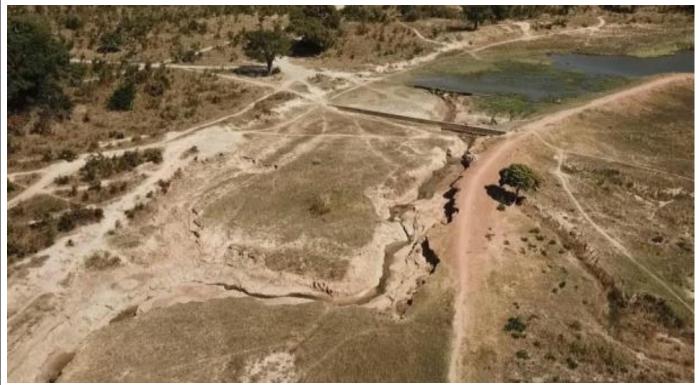
<u>Spillway Return Channel Training Wall:</u> The spillway discharge channel training wall running from the bend - at the spillway sill – to beyond the second concrete drop structure in the channel has a very narrow crest of approximately 2m and steep upstream and downstream slopes. Beyond this, the slopes flatten out considerably and the crest widens but the gullying in the channel has severely washed and undercut the wall – almost to the point of breakthrough - for a considerable distance towards the third drop structure – which itself has been completely washed away.

Spillway return channel showing drop structures, gullying and training wall washaway

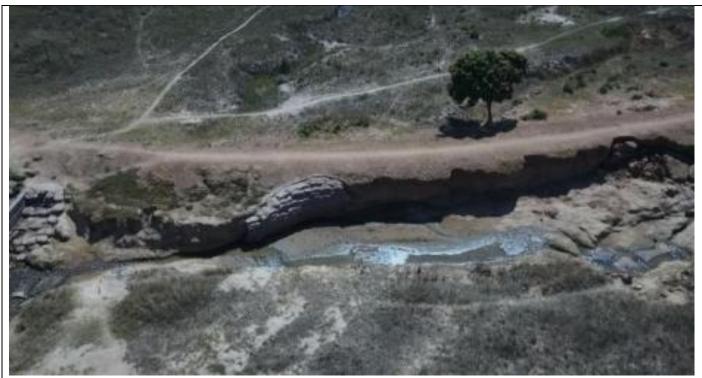
This is of a highly temporary nature and the serious undercutting of the wall beyond the sandbag repair is badly in need of some form of temporary repair to see this wall through the coming rains. This problem is better understood by studying the photo in the Figure below.

Temporary protection works needed for getting through the 2020/2021 rains

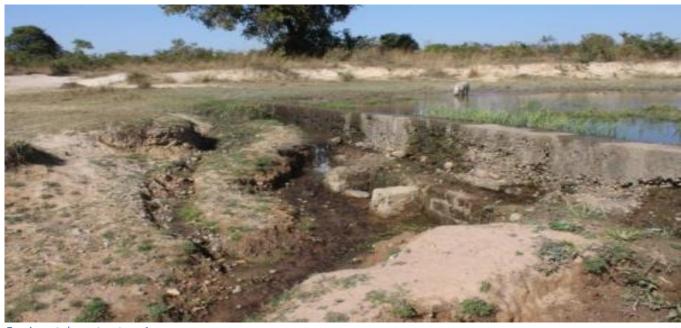
<u>Drop Structures:</u> There were originally three drop structures constructed down the length of the spillway return channel. Their design and operation in the prevailing ground conditions appears to be completely inadequate for the task at hand - as evidenced by the fact that the third drop structure has been completely washed away and the scour is such that there is no possibility of reinstating it in its original position. Similarly, both, drop structures 1 and 2, are being undercut by the gullying that is working its way steadily back up the channel towards the main spill section.

Erosion at drop structure 1

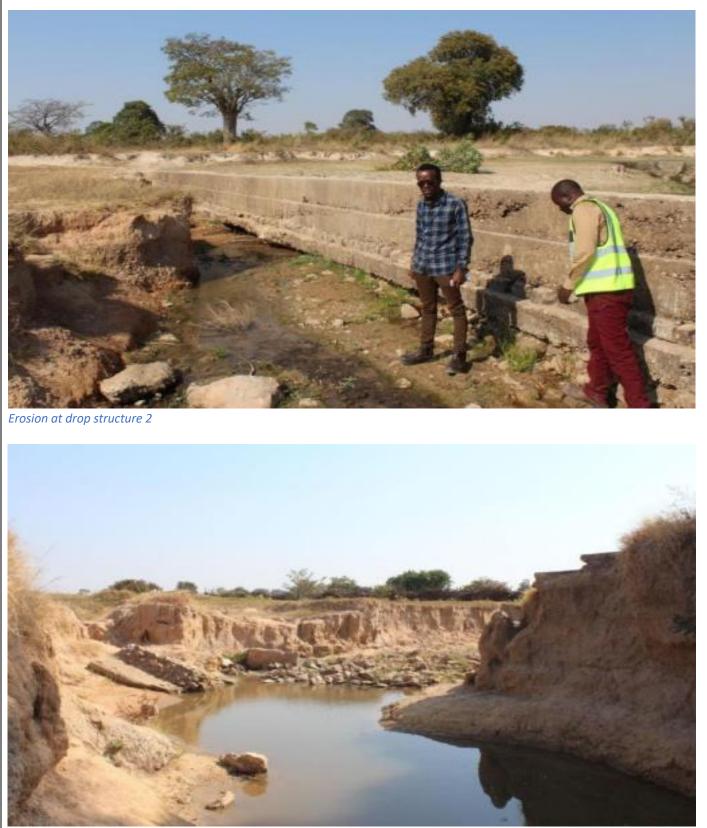
Total washaway of drop structure 3

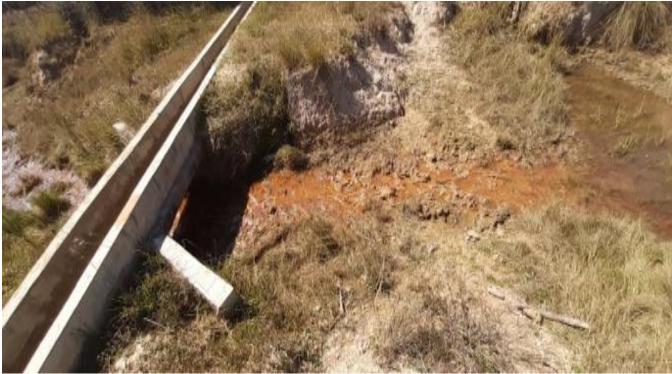
Figure 17: Drop structure condition

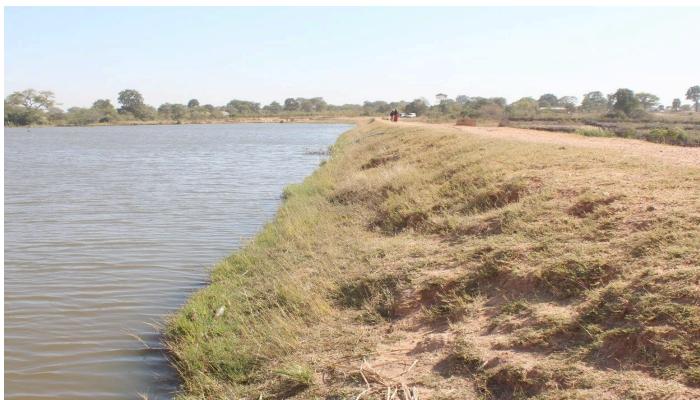
Figure 18: Front face condition requiring slope works

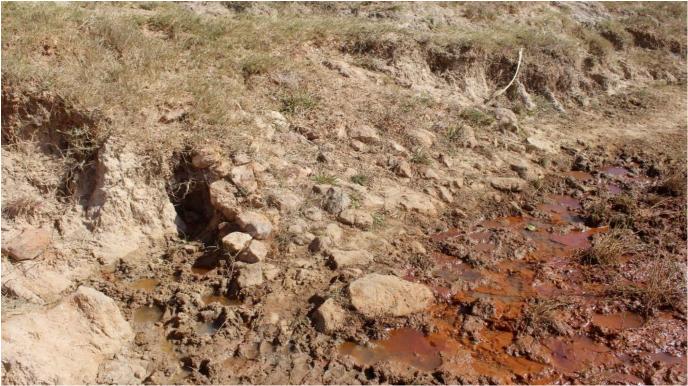
Figure 19: Seepage wet spot near rock toe location

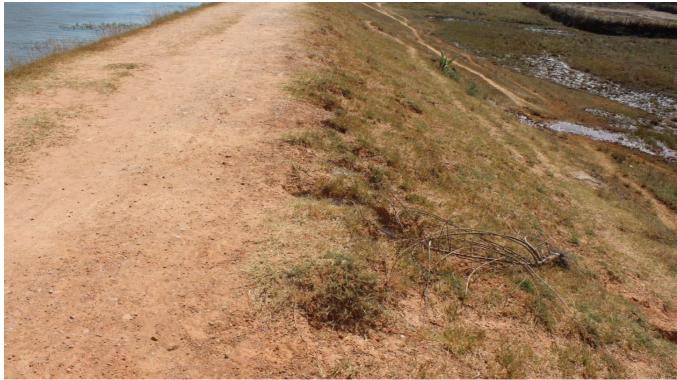
Figure 20: General condition of embankment crest

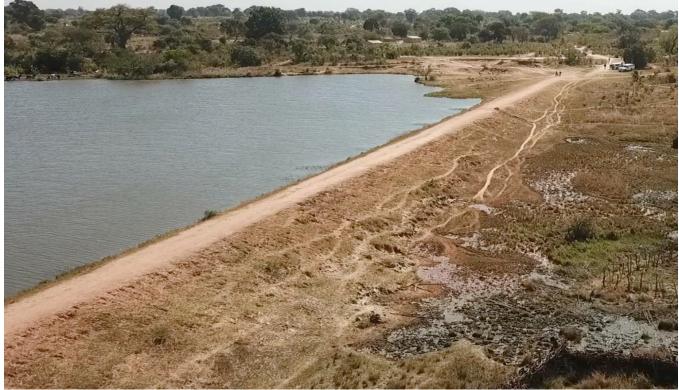
Figure 21: Seepage at and downstream of toe and livestock paths

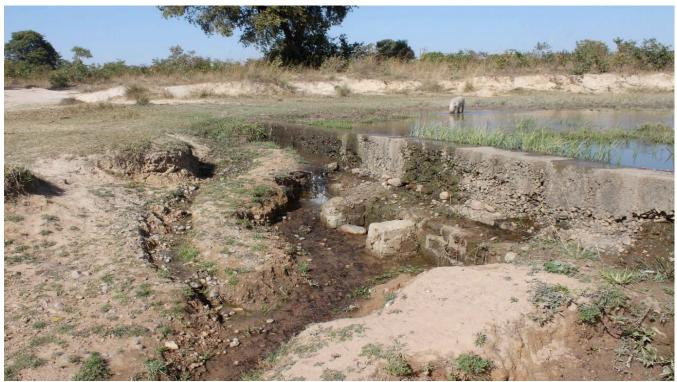
Figure 22: Erosion at Drop Structure 1

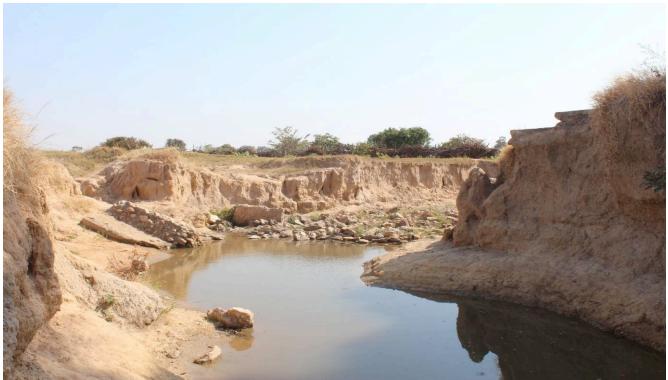
Figure 23: Total washaway of drop structure 3

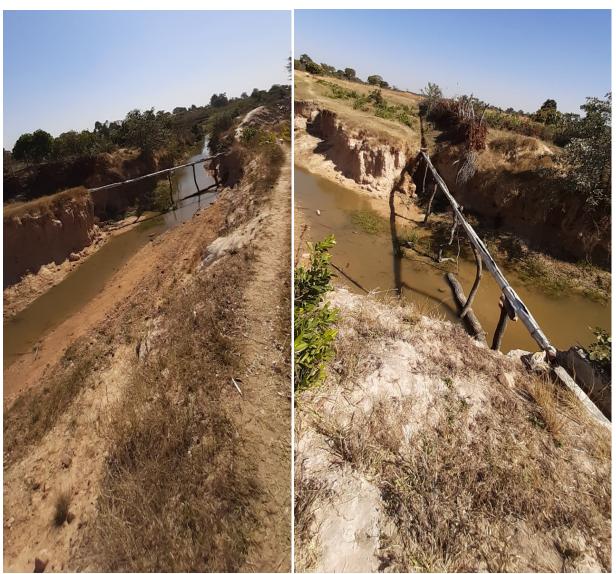
Figure 29: Broken canal over channel due to expanding eroded return channel- temporarily fixed using logs

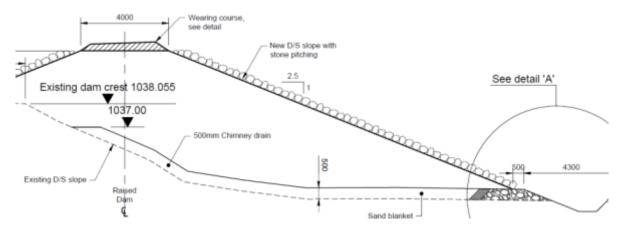
Figure 30: Raising cross section showing chimney filter location

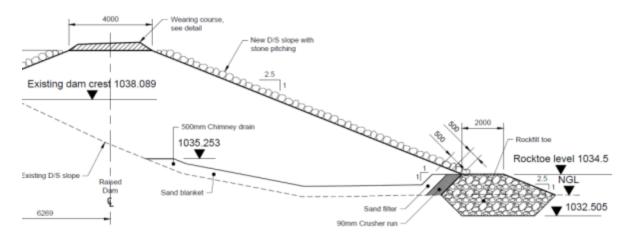
Figure 31: Typical Section of Rock Toe and Filter in the Riverbed Section

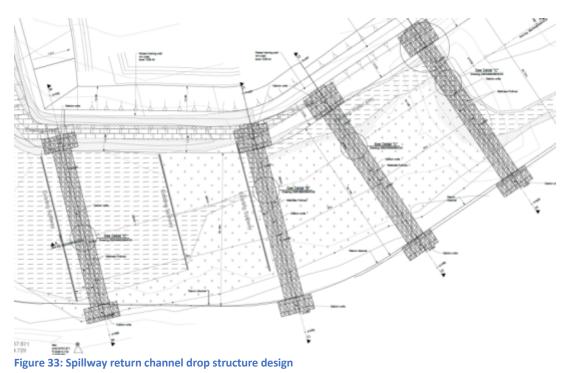
Each 1m drop on the downstream side of the gabion structure is protected with a 2m wide Reno Mattress on either side of the gabion bolster line to reduce the shallow undercut of the structure. The crest of the next drop structure is at the same level as the upstream drop. The channel will be stepped and levelled across its width between each drop and suitable material will be used for the embankment raising or the training wall remedial works. The critical point of each structure will be its connection with the training wall, as this is where the gullying may occur. A 2m gabion mattress will run up the entire embankment, both upstream and downstream of the head walls, and will be tied into the head wall and link into the mattresses.
