# **REVISED FINAL ENVIRONMENTAL AUDIT REPORT FOR THE IRRIGATION DEVELOPMENT SUPPORT PROJECT FUND (ISF) SITES IN MPIKA, MKUSHI, LUNDAZI, KABWE, LUANSHYA, KAFUE AND LUFWANYAMA**

## **ENVIRONMENTAL AUDIT REPORT**

IRRIGATION DEVELOPMENT SUPPORT PROJECT (IDSP)  
CREDIT NO. P172140

**February 2024**

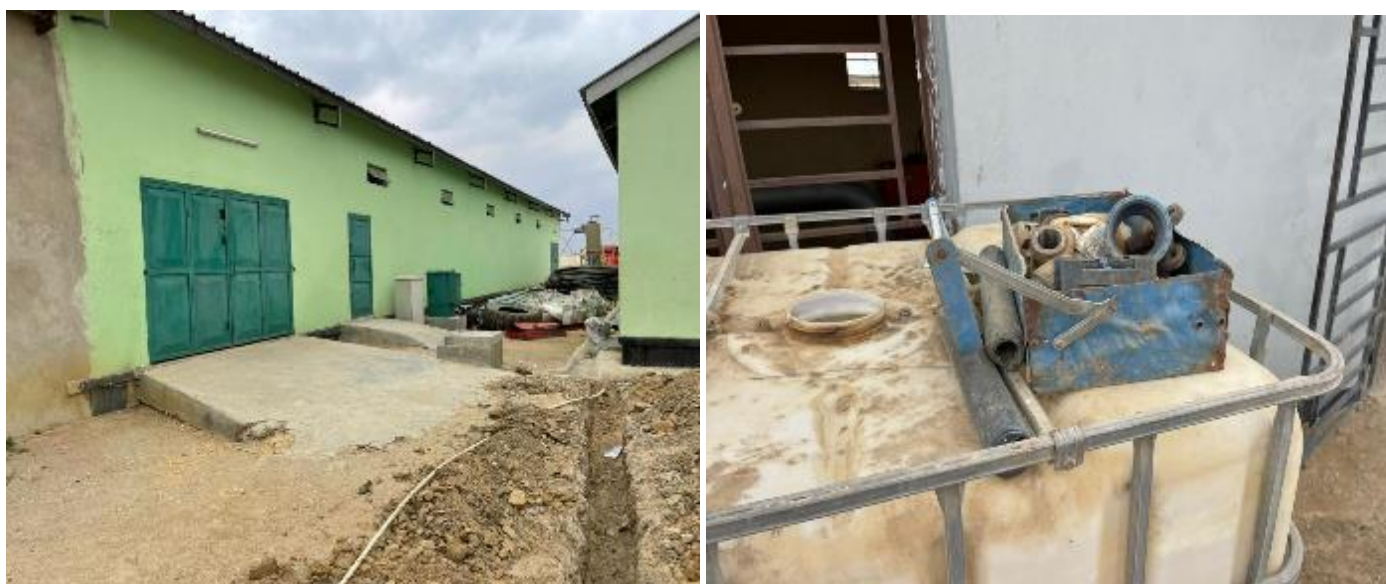
- Some machinery parts were observed near the pump house not properly stored in the workshop hence posing a risk of contamination of the soil.
- The Chemical storage facility is kept under lock and key. However, the chemical storage facility entrance is not labelled to show that there are different type of Hazardous Materials.

*Figure 3 shows the Chemical Warehouse that is not labelled and Machinery parts not properly stored*

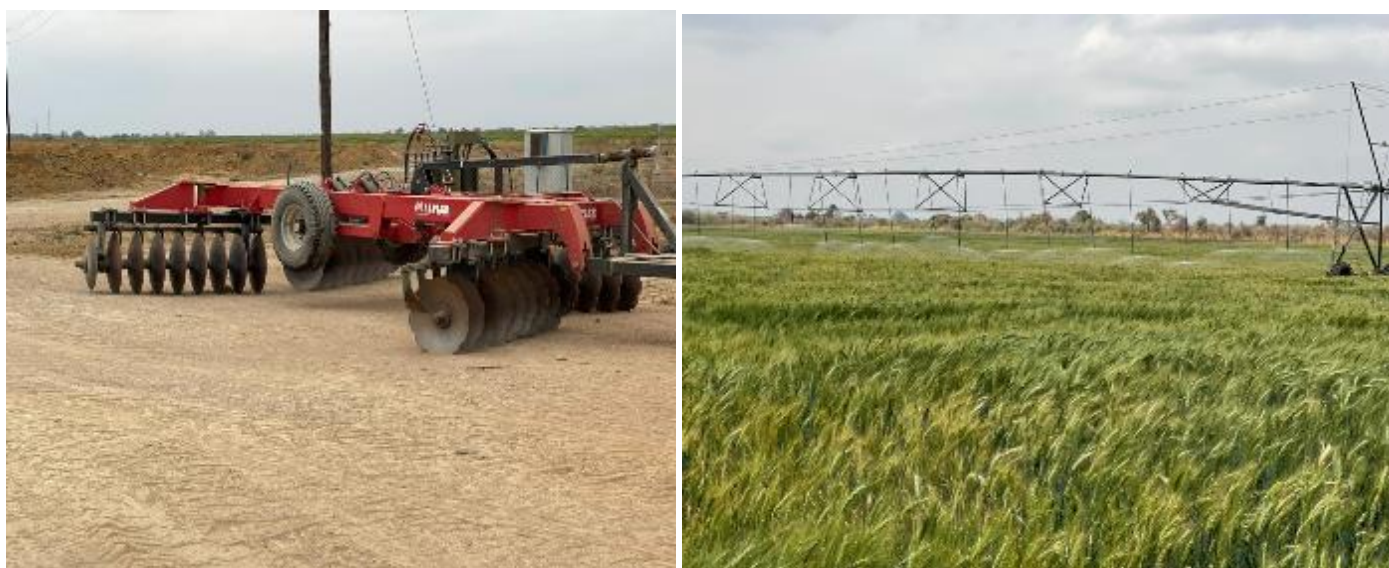
Figure 4 shows the Plough and Centre Pivots some of the benefits from the IDSP

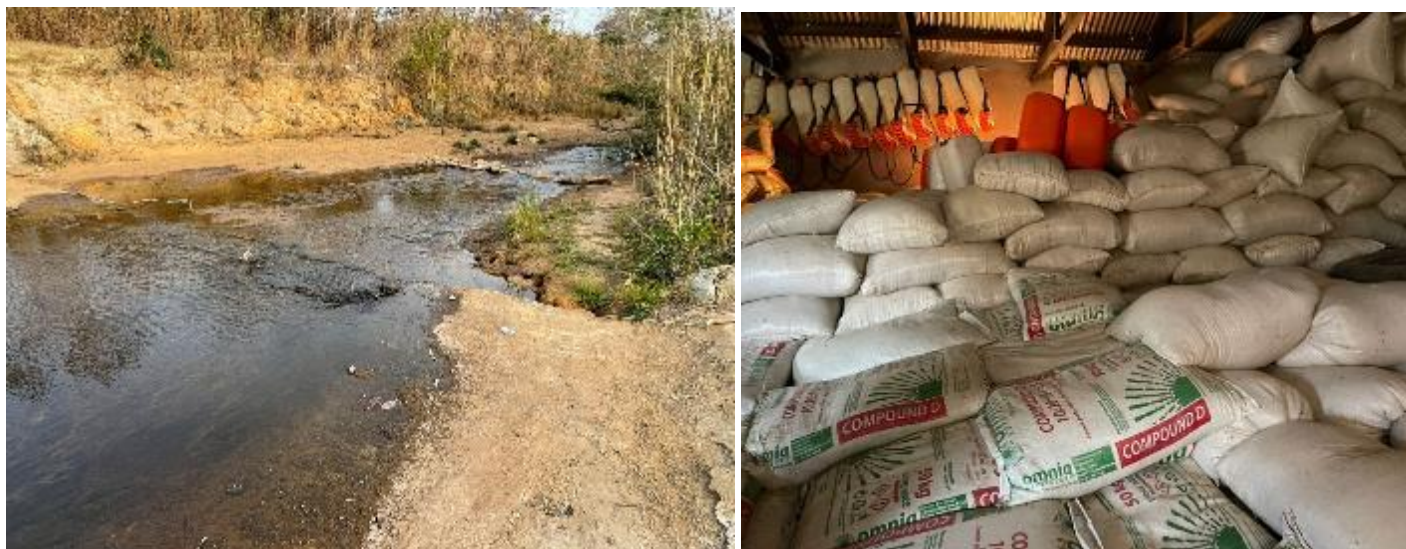
- The Farm staff receive HIV/AIDS awareness 3 times a month from USAID.
- The standby Generator is properly placed on a concrete surface. However, a bund wall is required to be installed incase of fuel spillage.

- A drainage around the farm boundary is recommended to be constructed to avoid water pollution.
- The farm lacks an empty chemical container disposal site which should be approved by Zambia Environmental Management Agency.

Figure 5 shows the spillway allowing water to go back to the stream and storage facility requiring pallets

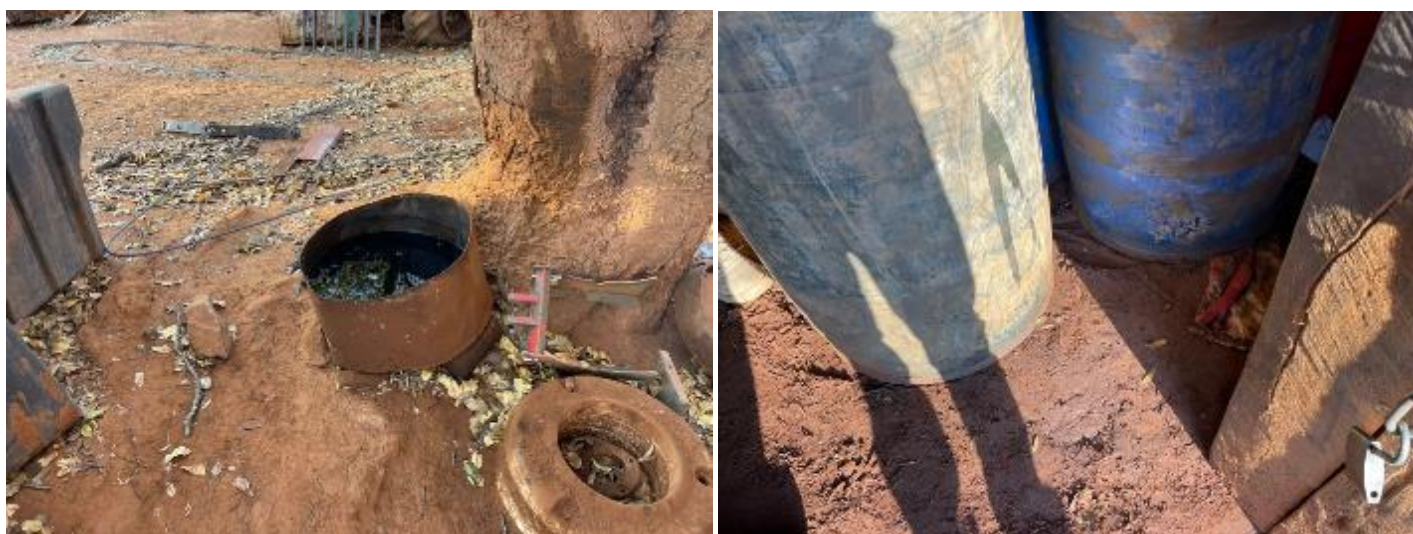
Figure 7 shows the Used oil not properly stored and the surface of the fuel storage facility that is not concreted

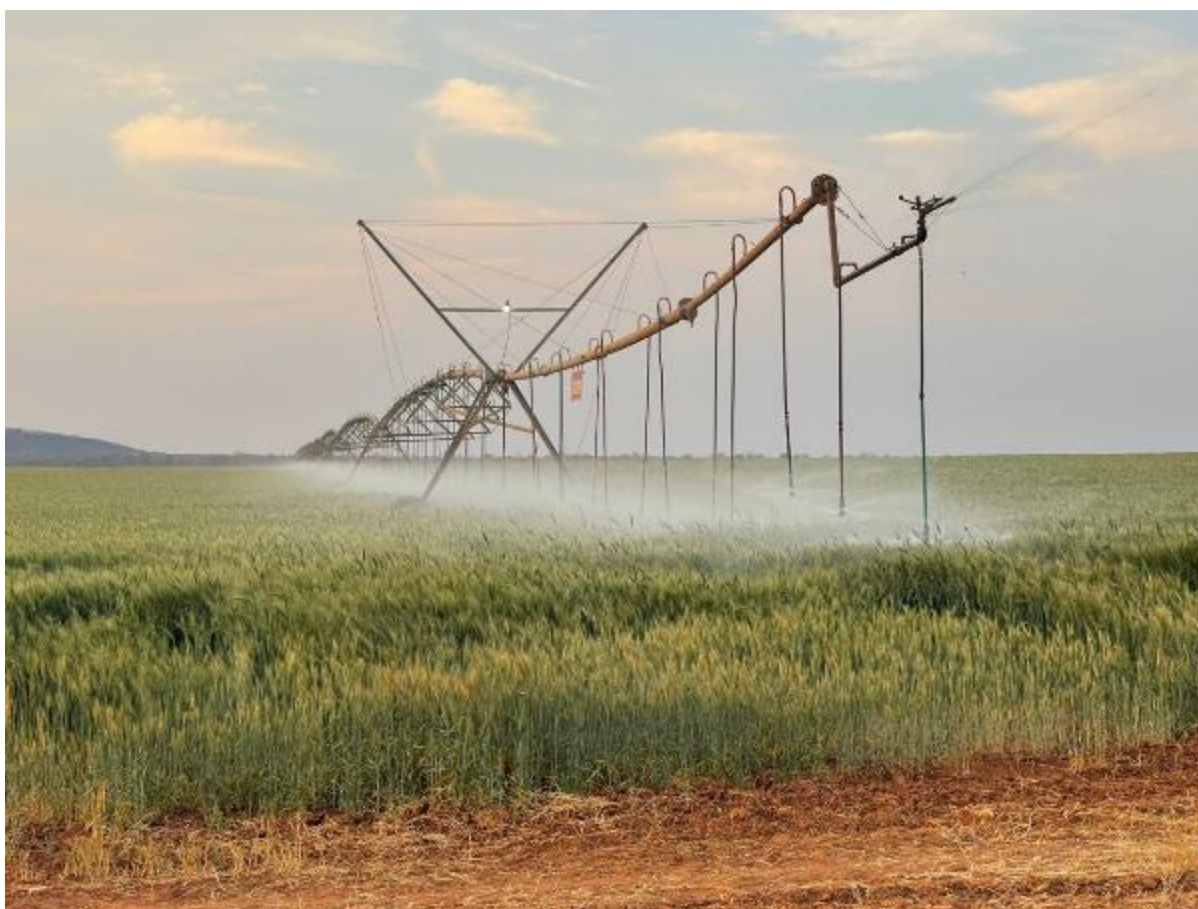
*Figure 10 shows the Centre Pivot in fully operational*

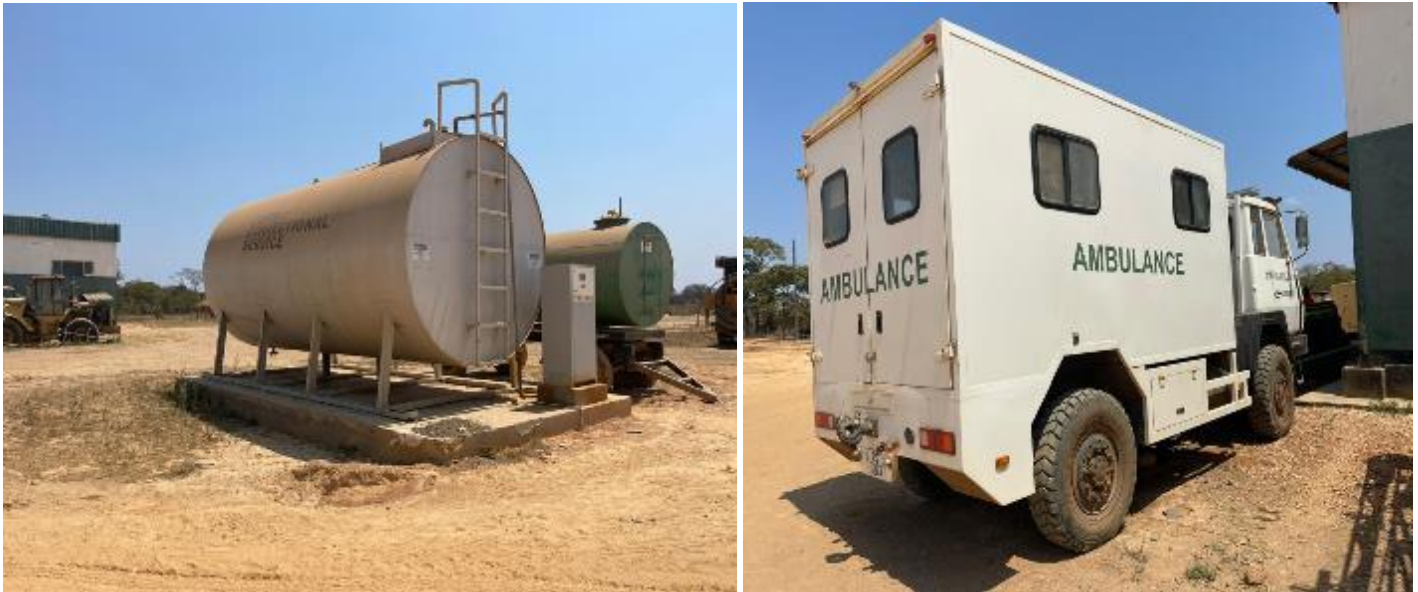
- The farm lacks an empty chemical container disposal site which should be approved by Zambia Environmental Management Agency.

Figure 11 shows the Fuel tank without a bund wall and the Emergency Vehicle found at the farm

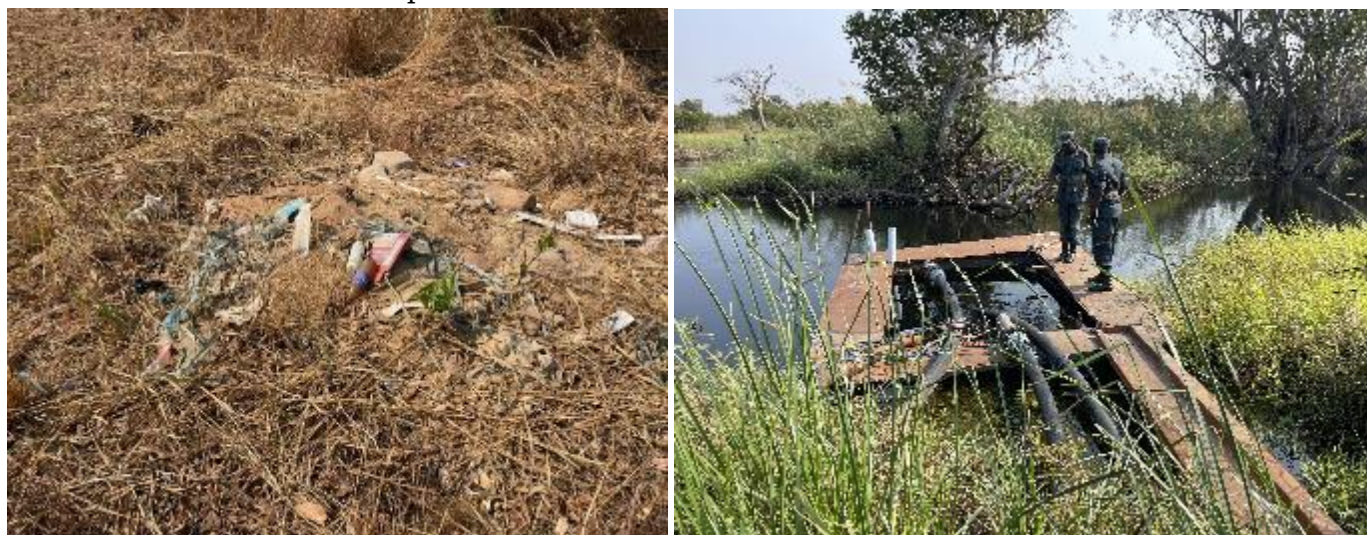
- The Farm staff receive HIV/AIDS awareness through the Clinic within the farm.
- Waste management is not fully followed as some solid waste was dumped in some sections of the farm.

Figure 13 shows the solid waste disposed off within the farm and the water abstraction point

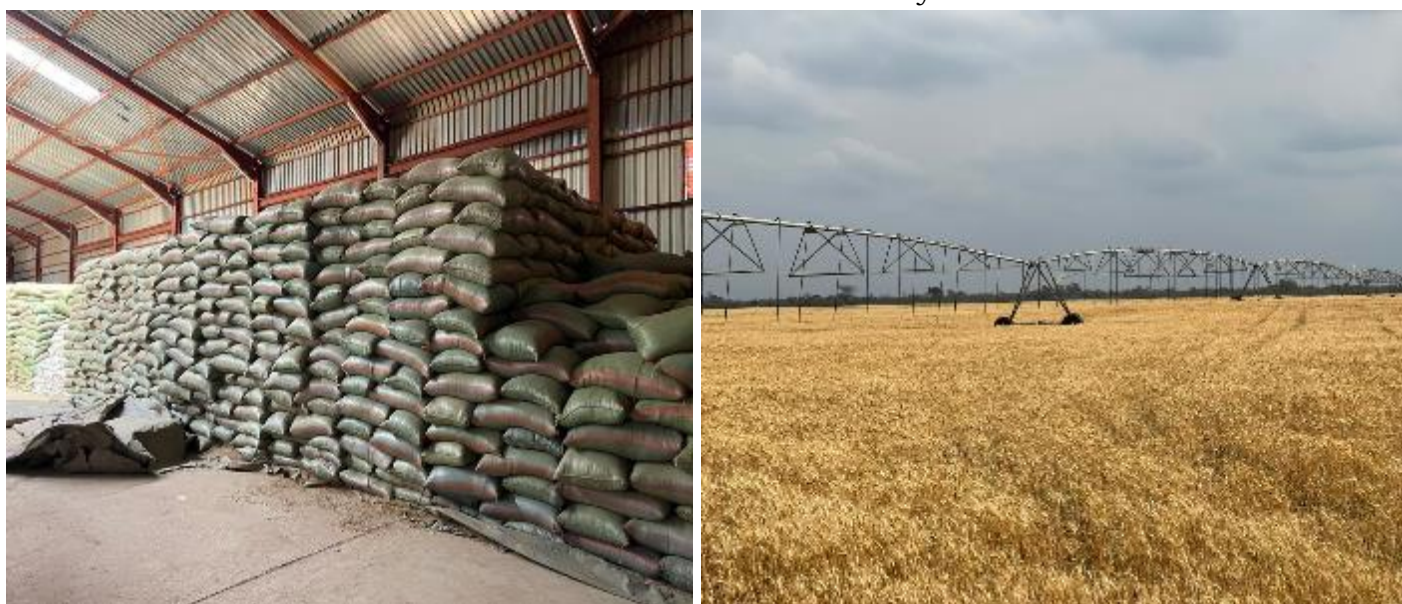
Figure 14 shows the soyabeans harvest and one of Centre Pivot at the farm

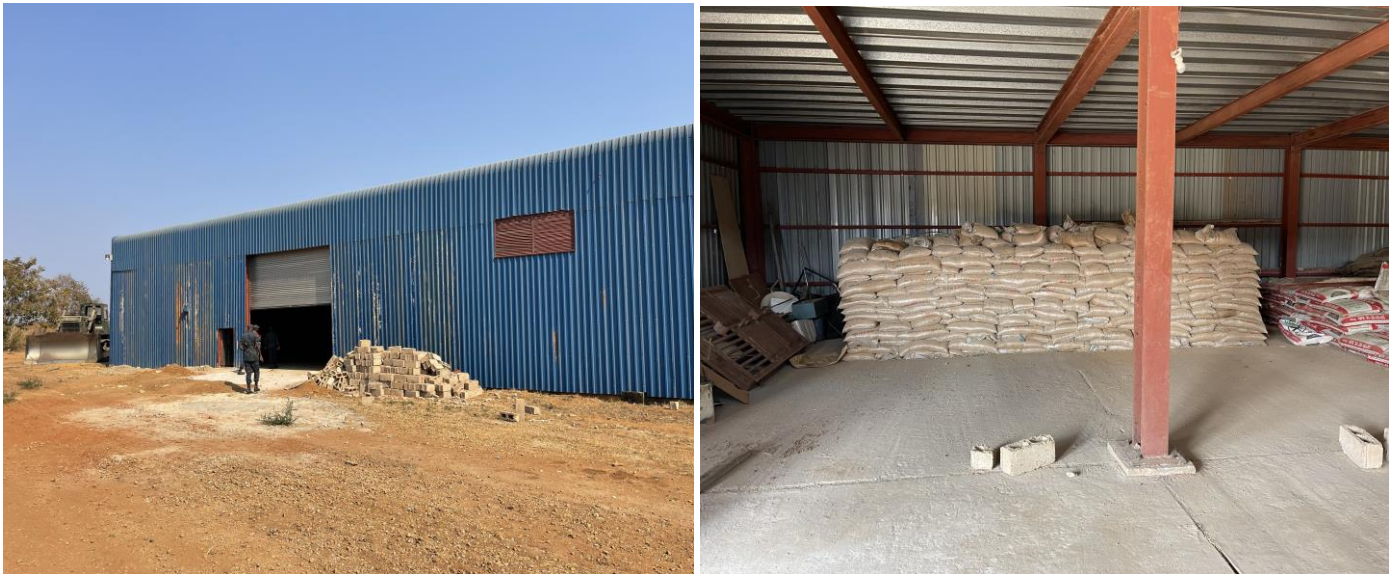
- The Environmental management practices within the farm are partially being followed at the farm as some of the required practices such as proper disposal of pesticide containers is not followed.
- Vegetation clearance has been restricted to areas only meant for storage shed.
- Some workers in the farm were not in fully Proper Protective Proper Equipment.
- The storage shed area has does not have a no smoking area.

Figure 15 shows the completed storage shed entrance and the inside of the shed without signage

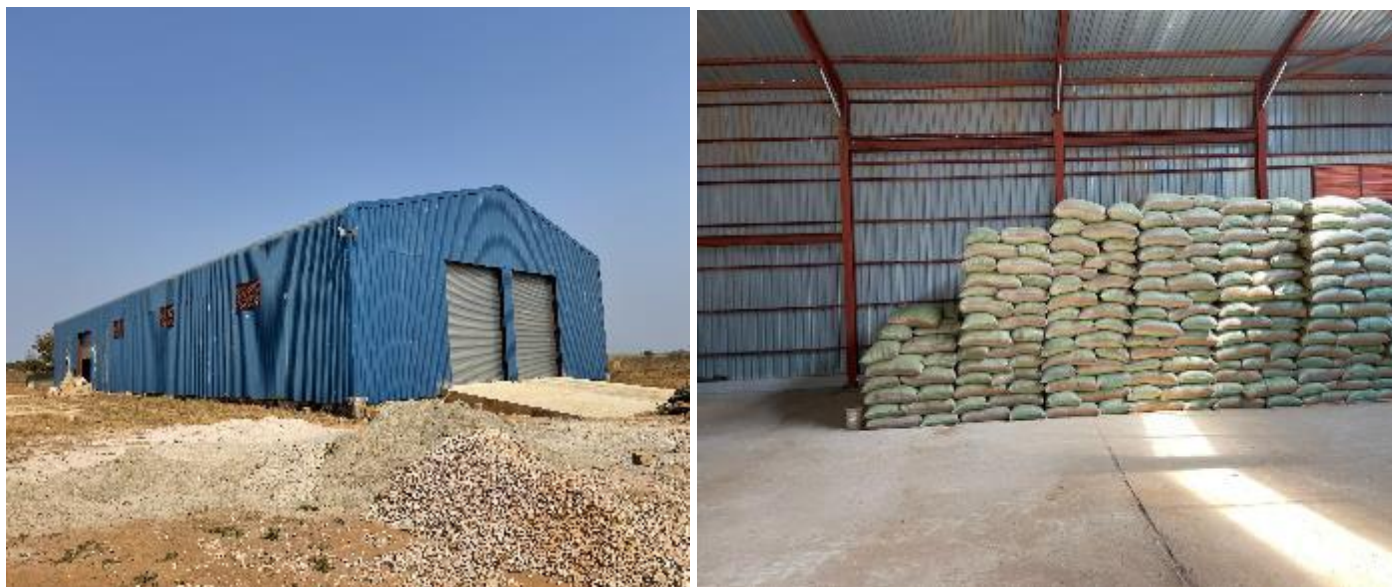
Figure 16 shows the completed shed facility and the soybeans stocked inside

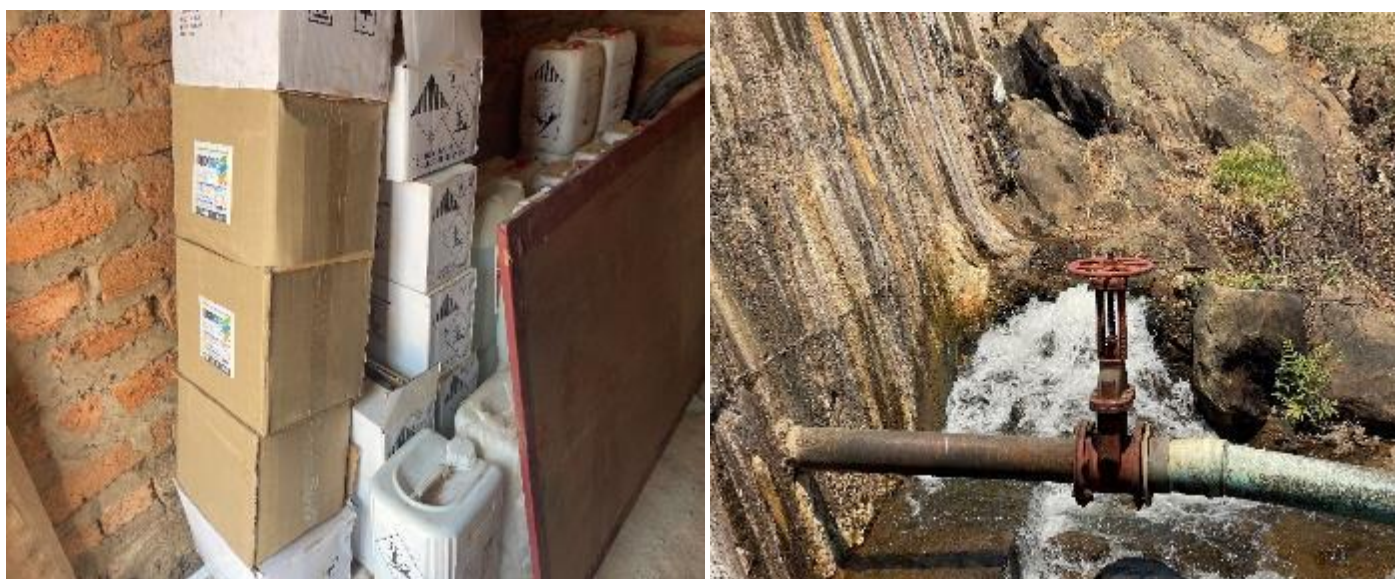
- The farm lacks an empty chemical container disposal site which should be approved by Zambia Environmental Management Agency.
- The farm has dam with a weir that collects water for irrigation. The dam was found to have environmental flows and was allowing water to continue flowing down stream. However, there is need to rehabilitate the dam weir.

- Vegetation was found to be growing along side of the dam.

Figure 17 shows the chemical storage facility and the weir with environmental flows observed

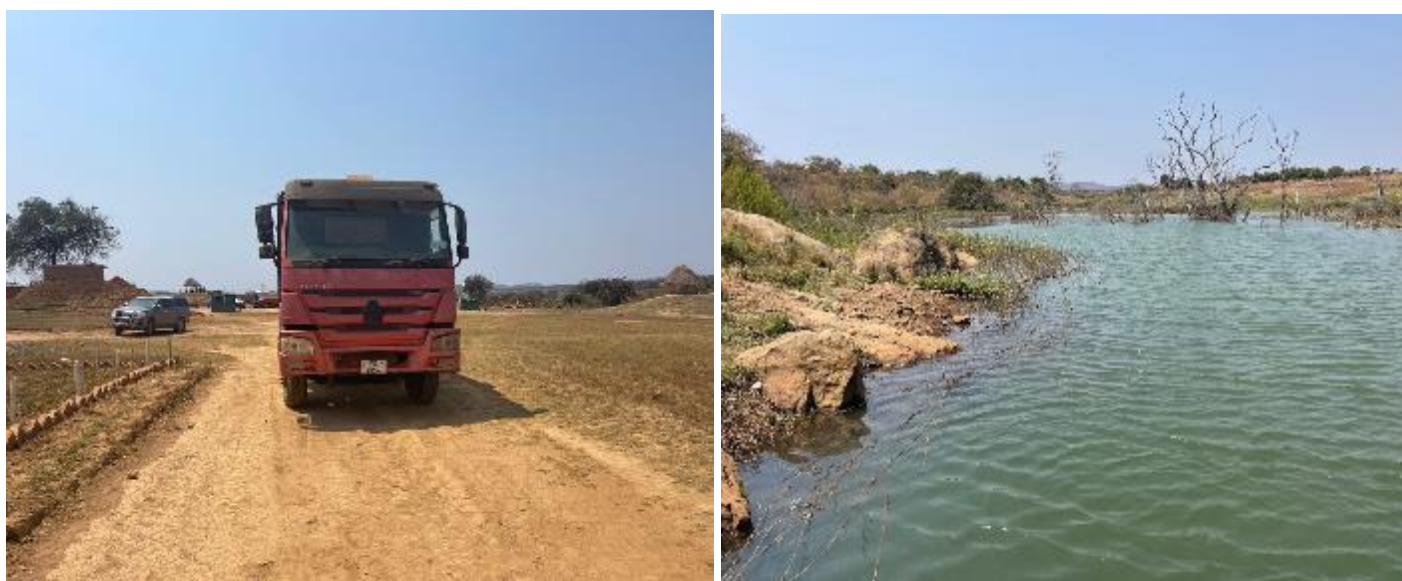
Figure 18 shows the Tipper Truck and Dam within the farm

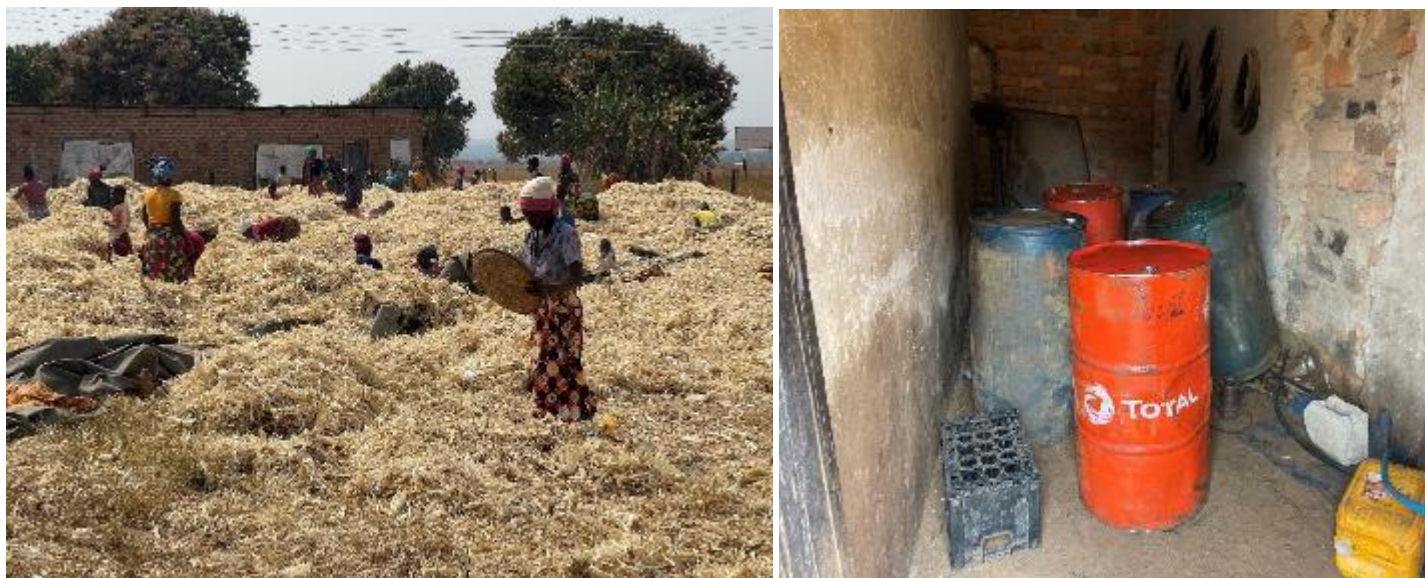
Figure 19 shows the locals employed to help during the harvesting period and the fuel storage facility within a concrete surface

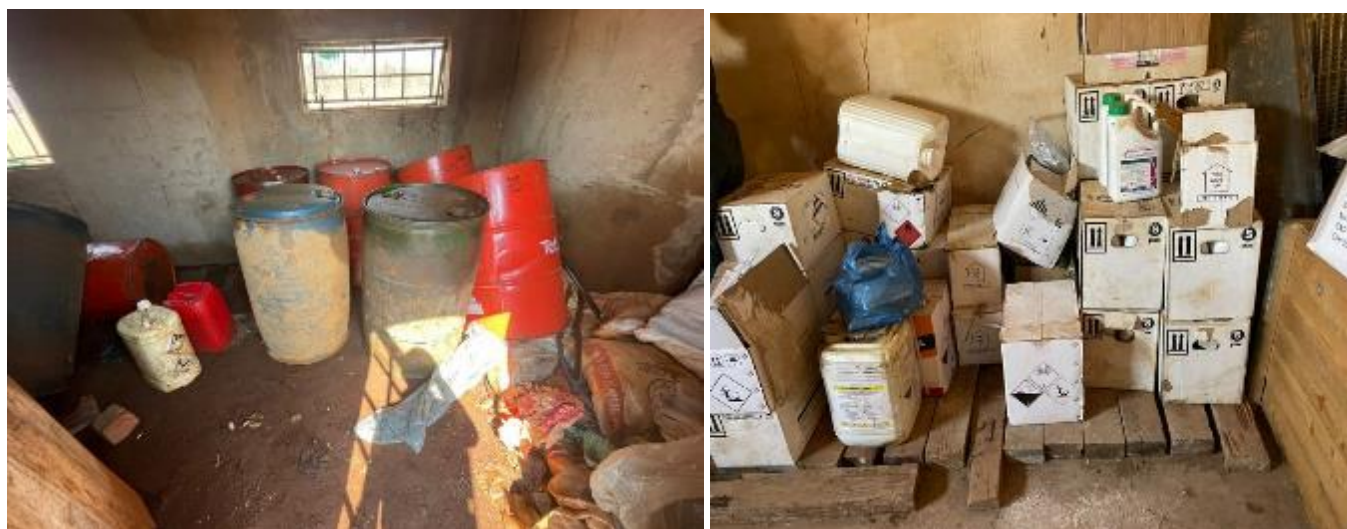
- **Non-Compliance:** The chemical and fuel storage facilities at the Public Institutions (ISF sites) were found not to have proper signage showing hazardous materials or flammable materials, the facilities were not concreted to avoid pollution. Furthermore, Fire extinguishers were not found at these sites.

Figure 22 shows the fuel facility and chemical storage facilities

**Proposed Actions:** The Public Institutions (ISF sites) must ensure that that their fuel storage facilities are concreted, signage properly placed, spill kits must always be present within the facility incase of emergencies, a Fire extinguisher must always be present. The chemical facilities should have proper signage, chemicals must be placed on pallets.
